Waste disposal given a new facelift

Building summary

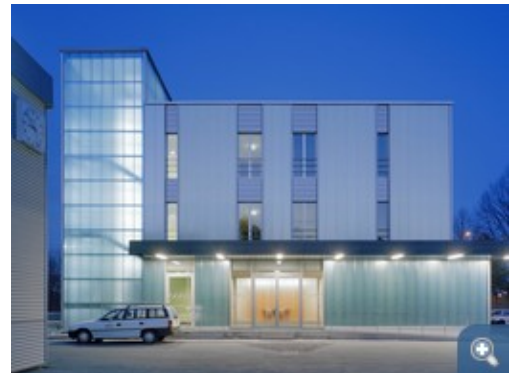
New entrance area on the west side at night.
© AC Müller Schlüter. Foto: Thomas Riehle

Because the previous main entrance was located in an awkward position, it was moved to the rear end on the west side where it is more easily accessible. The vehicle garage behind it is now used as a small foyer that gives access to the customer centre and the new, barrier-free circulation core.
