# Stuttgart-Sonnenberg nursing home for the elderly

The retirement home, built in Stuttgart-Sonnenberg (Germany) in 1965, is a good example of the possibilities presented by simultaneous refurbishment of the building and of the system technology. Many houses, originally intended to be retirement homes, come to be used primarily as nursing homes, which also entails changes to the requirements regarding fittings. Some of the modernisation work which thus becomes necessary (e.g. installation of bathrooms in residents' rooms) requires alteration of the building structure. If this is coupled with energy-related refurbishment measures, it is usually the case that, while the living comfort and attractiveness increase, the energy costs reduce significantly.

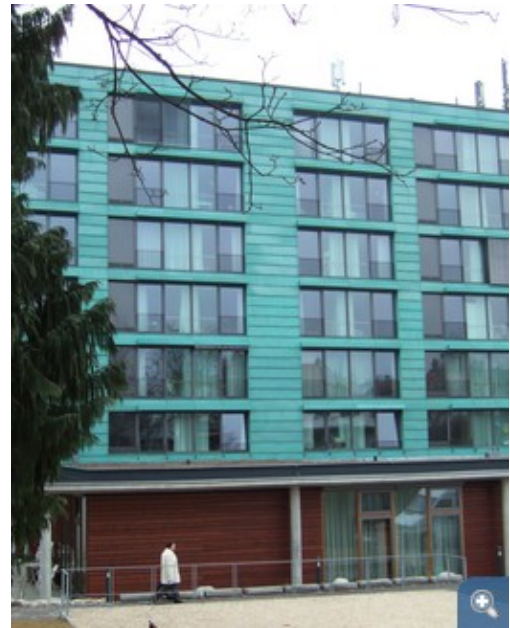
The new facade of the nursery home for the elderly in Stuttgart-Sonnenberg.  
© Fraunhofer IBP

A new facade in front of the residential rooms' balconies solves two problems at once: the concrete cantilevers' thermal bridges disappear, and the balconies' floor area can be added to the residential rooms (as it was, residents in need of nursing care made no use of the balconies). This creates space to retrofit bathroom units in

the rooms. The new lightweight facade consists of a wooden post-and-beam structure with timber web t-beams, the thermal bridging properties of which are minimised. The windows in frames made of wood and aluminium, optimised for thermal insulation, have thermally insulating triple glazing with thermally optimised spacers. Air vent openings in the frames allow air renewal in the residents' rooms, necessary for reasons of hygiene. A special fitting which prevents tilt-opening of windows during heating periods should prevent the previously prevalent practice of ventilating via permanently tilted windows. For extension and illumination of the lounge areas, two neighbouring residential rooms on the west side were removed on each storey. A 20 cm-thick thermal insulation composite system was installed on the northern and southern facades. The roof, the ceiling of the unheated cellar, and the walls of the heated areas in the cellar, were also insulated. All thermal insulation measures combined reduce the building's transmission heat losses by more than 70%.
